**From:** Frank Morabito <[frank@morabitoconsultants.com](mailto:frank@morabitoconsultants.com)>  
**Date:** October 8, 2018 at 2:27:40 PM EDT  
**To:** "Maggie Manrara ([gatormaggie@aol.com](mailto:gatormaggie@aol.com))" <[gatormaggie@aol.com](mailto:gatormaggie@aol.com)>  
**Subject:** CTS - Revised Reports and Estimates

October 5, 2018

Champlain Tower South Condominium  
8777 Collins Avenue  
Surfside, FL 33154

Morabito Consultants, Inc. (MC) is pleased to submit this structural engineering report of the Field Survey completed at the existing Champlain Towers South Condominium Complex (CTS) in Surfside, FL. The scope of this project includes a review of the existing 12 story plus penthouse 136-unit residential building, below-grade parking garage and at-grade exterior entrance drive, pool and recreation area. MC reviewed a representative sample of ~68 condominium units (half of the total units found in the building) along with the roof, exterior façade (observed from the balconies surveyed), parking garage, pool deck, and general common areas. The goal of our study was to understand and document the extent of structural issues that require repair and/or remediation in the imm

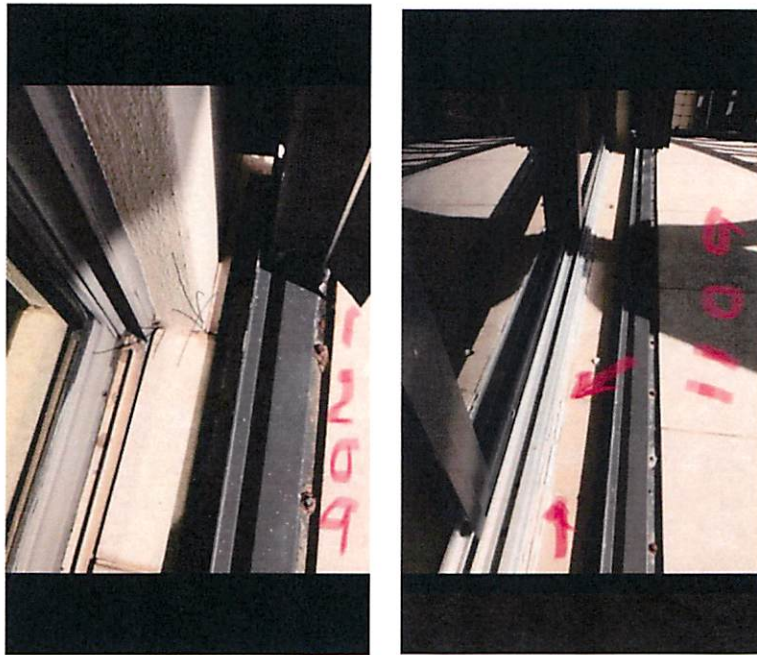
- A. MC understands some unit owners have complained of flooding into the interior space of their unit during a hurricane event. MC has concluded that this infiltration is occurring through the balcony sliding glass doors & windows due to the lack of proper flashing at the sill of these doors & windows and deteriorated exterior perimeter sealant between the window/door frames and masonry/concrete walls. MC recommends that the exterior sealant be removed / replaced at the sliding glass door & window perimeter to assist in providing a water-tight condition. Unfortunately, the new sliding doors in unit 209 and above were not installed properly and were fabricated too tall to allow the base flashing to be properly installed, so these unit owners have no choice but to discard the newly purchased doors and have them completely refabricated.

Figure A1: Exterior sealant past its serviceable lifespan at sealant between the window/door frames and masonry/concrete walls & balcony floors

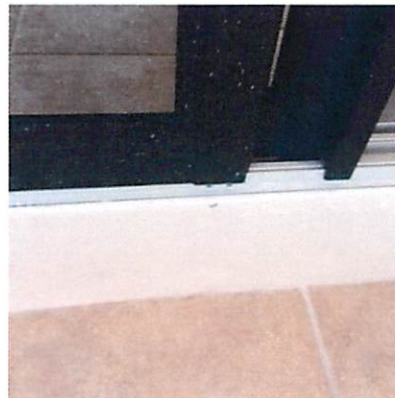
Figure A2: Newly installed sliding door at unit 209 that was not properly flashed

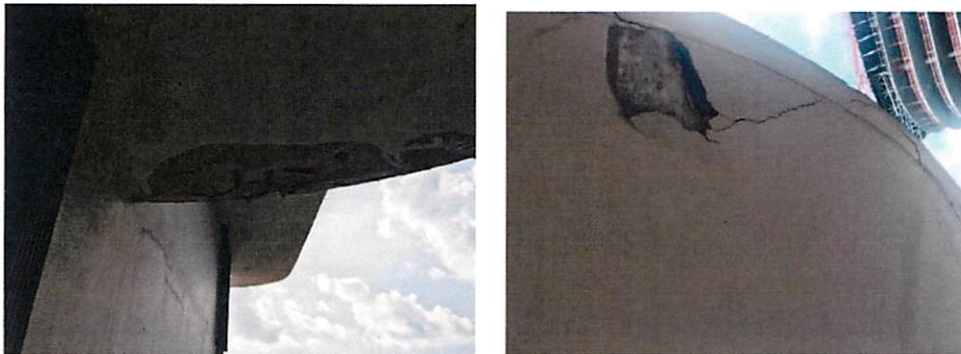
- C. MC found it fairly typical that the concrete slab edges of the balconies are experiencing concrete spalling or cracking. MC sees this as a common source of water infiltration and a main cause of the commonly found, sub-surface deterioration at the exterior soffits under the railings. MC requires that the balcony slab edges be further investigated and repaired in accordance with the recommendations of the ICRI to prevent future water penetration.

Figure C: Concrete spall at balcony slab edge in units 1008 & 211

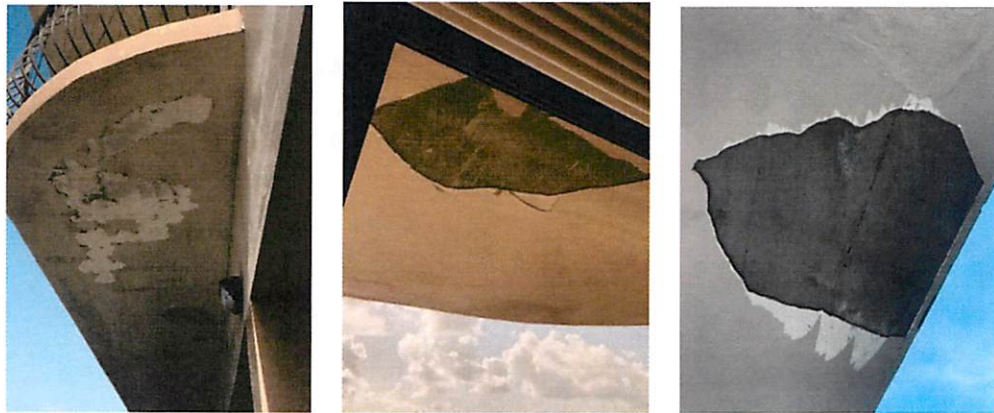
- D. Approximately half of the balcony soffits reviewed by MC show evidence of deterioration under the painted finished surface. These areas were identified by sounding the concrete with a golf club, checking for solidarity. In some cases, the paint finish had formed a bubble or pocket that was retaining water, while in other areas the painted soffit was peeled away leaving the concrete surface exposed. The extensive soffit damage is a systemic issue that can only be repaired by removing all of the balcony tile, repairing the damaged concrete surfaces at the top and bottom of the slab and protecting the slab by installing a pedestrian waterproofing membrane on all top-side balcony surfaces. Partial/full depth concrete repairs in these areas shall be performed in accordance with the recommendations of ICRI. It is important to note that installing tile on top of the concrete balcony surfaces results in the railing having inadequate height to meet the minimum guardrail height of 42" required by the Florida Building Code.

Figure D: Balcony Soffit paint spalling in units 208, 703, & 1301.

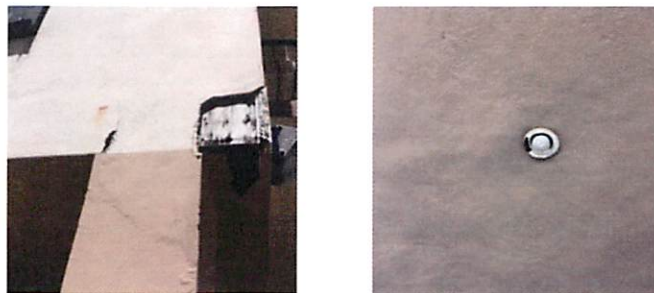
- E. Several areas of the entrance drive soffits under the second floor were observed by MC to have deteriorated black plywood. This condition was also observed at several light fixtures in the entrance soffit. MC could not get access into the soffit areas to observe the extent of the deteriorated soffits and support framing as CTS maintenance was too busy to assist us. MC is concerned that mold exists above these soffit areas and the soffit support framing is deteriorated which will require the complete removal and replacement of the entrance suspended soffit. Further investigation into this area is warranted.

Figure E: Deteriorated plywood soffit above entrance drive.

| # | ITEM | FAÇADE REPAIR ITEMS AND SCOPE | Estimated Quantity | | Unit Price | | Total Estimate |
|---|---|---|---|---|---|---|---|
| 24 | PRA | Remove and Replace Existing Suspended Soffits Below 2nd Floor Exterior Slabs<br>Includes fabrication & installation of new anchorages and repair of roofing | 12,800 | Sf | \$28.00 | /SF | \$358,400.00 |

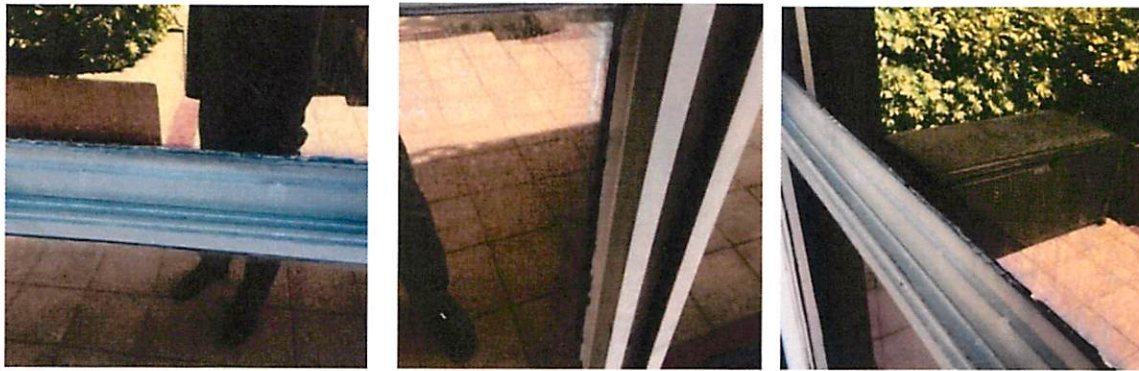
- F. It was brought to MC's attention that several units are experiencing water infiltration through the window frames and glazing as the windows are near the end of their functional lifespan. It is recommended that the window frame glazing (metal to glass), and perimeter sealant (metal to metal or metal to masonry/concrete) be removed and replaced for the entirety of the building to reduce future water penetration and minimize damage during hurricane events. MC recommends that the BOD strongly consider the replacement of all exterior windows and doors with impact resistant units.

Figure F: Exterior sealant at window frame that has aged past its serviceable lifespan

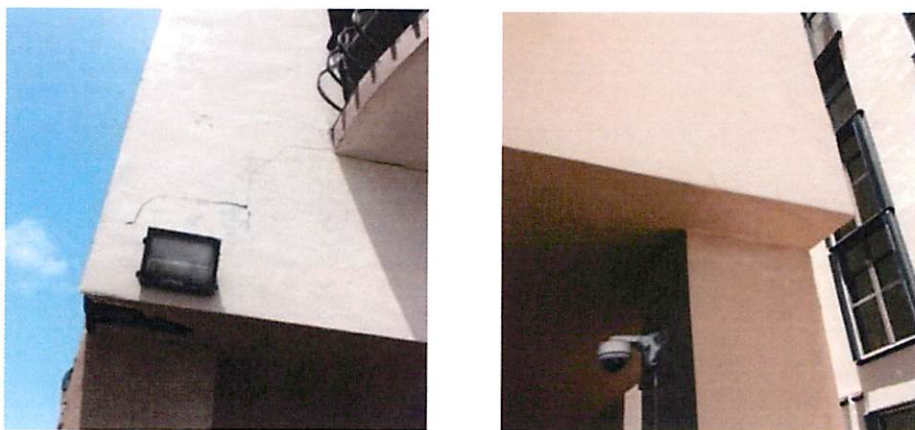
- G. Significant cracking in the stucco exterior façade often occurs at the mortar bed joint between the top of the concrete floor slab and first block masonry course. Although MC does not see this crack as a source of water infiltration into the condominium units, such cracks need to be routed and repointed to prevent future water permeation. All significant façade stucco cracking is to be repaired in accordance with the recommendations of ICRI.

Figure G: Typical cracking in the stucco exterior facade.

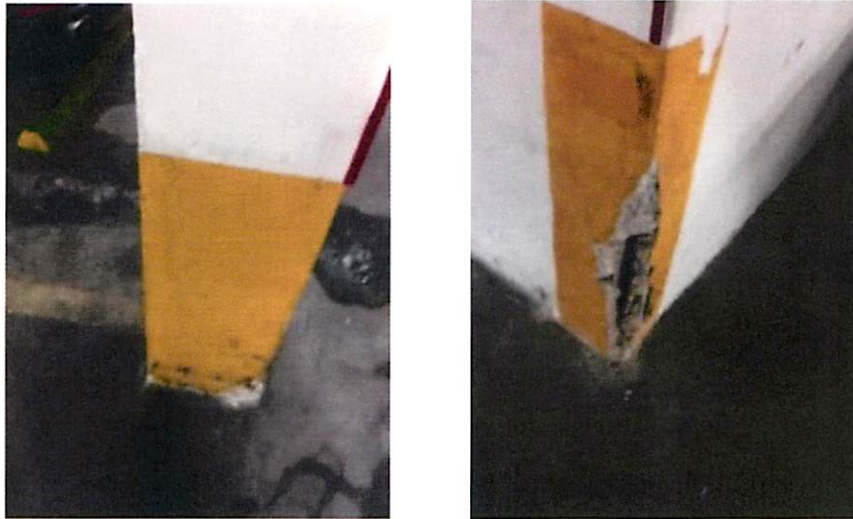
- J. Abundant cracking and spalling of varying degrees was observed in the concrete columns, beams, and walls. Several sizeable spalls were noted in both the topside of the entrance drive ramp and underside of the pool/entrance drive/planter slabs, which included instances with exposed, deteriorating rebar. Though some of this damage is minor, most of the concrete deterioration needs to be repaired in a timely fashion. All cracking and spalling located in the parking garage shall be repaired in accordance with the recommendations of ICRI.

Figure J1: Typical cracking and spalling at parking garage columns

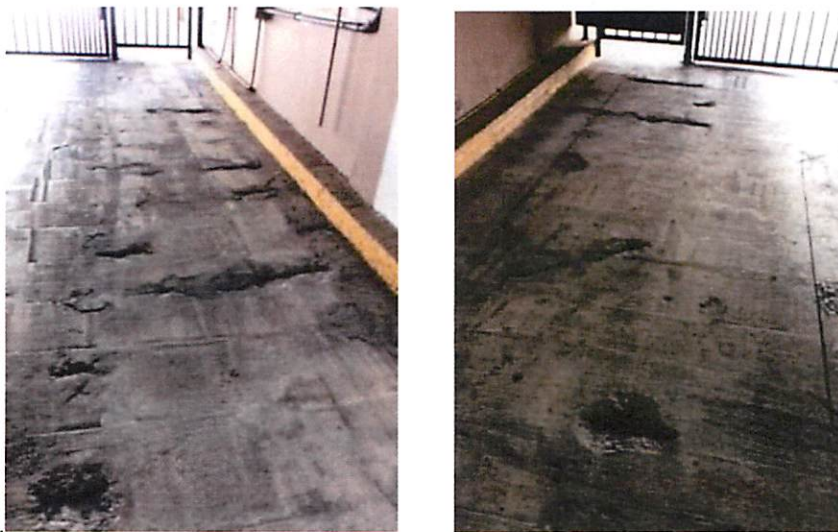
Figure J2: Spalling with exposed steel reinforcement at topside of garage deck.
